NONDESTRUCTIVE TESTING REPORT

CUSTOMER: ARISPE AVIATION (AIRSPEED AND ATTITUDE)	LOCATION: MCKINNEY, TX	
MANUFACTURER: CESSNA	MODEL: 177B	
REGISTRATION: N34904	SERIAL NUMBER: 17702078	
TOTAL HOURS: 5620.3	TOTAL LANDINGS: N/A	
DATE INSPECTED: 06 APRIL 2023	PRELIMINARY INSPECTION <input checked="" type="checkbox"/> YES <input type="checkbox"/> NO	HIDDEN DAMAGE INSPECTION <input type="checkbox"/> YES <input type="checkbox"/> NO <input checked="" type="checkbox"/> N/A
INSPECTION PROCEDURE/SPECIFICATION SEE BELOW		
EQUIPMENT/CALIBRATION/STANDARDS USED NORTEC 600: S/N 210128701, C/D 17FEB2024 100-500 KHZ PROBE AL EDM STANDARD

BY TEXTRON AVIATION
	Checker	<i>[Signature]</i>			
	Checker				Field Repair - Corrosion, Fuselage, Cantilever Wing Carry-Thru Spar, Lower Spar Cap Surface
	Specialist				
	Specialist	Size	CAGE Code	Drawing No.	
Approved	<i>[Signature]</i>	A	7EK50	FR-17702078-11811	-
Scale		233 None		Sheet	
				1 of 5

MAJOR REPAIR AND ALTERATION
(Airframe, Powerplant, Propeller, or Appliance)

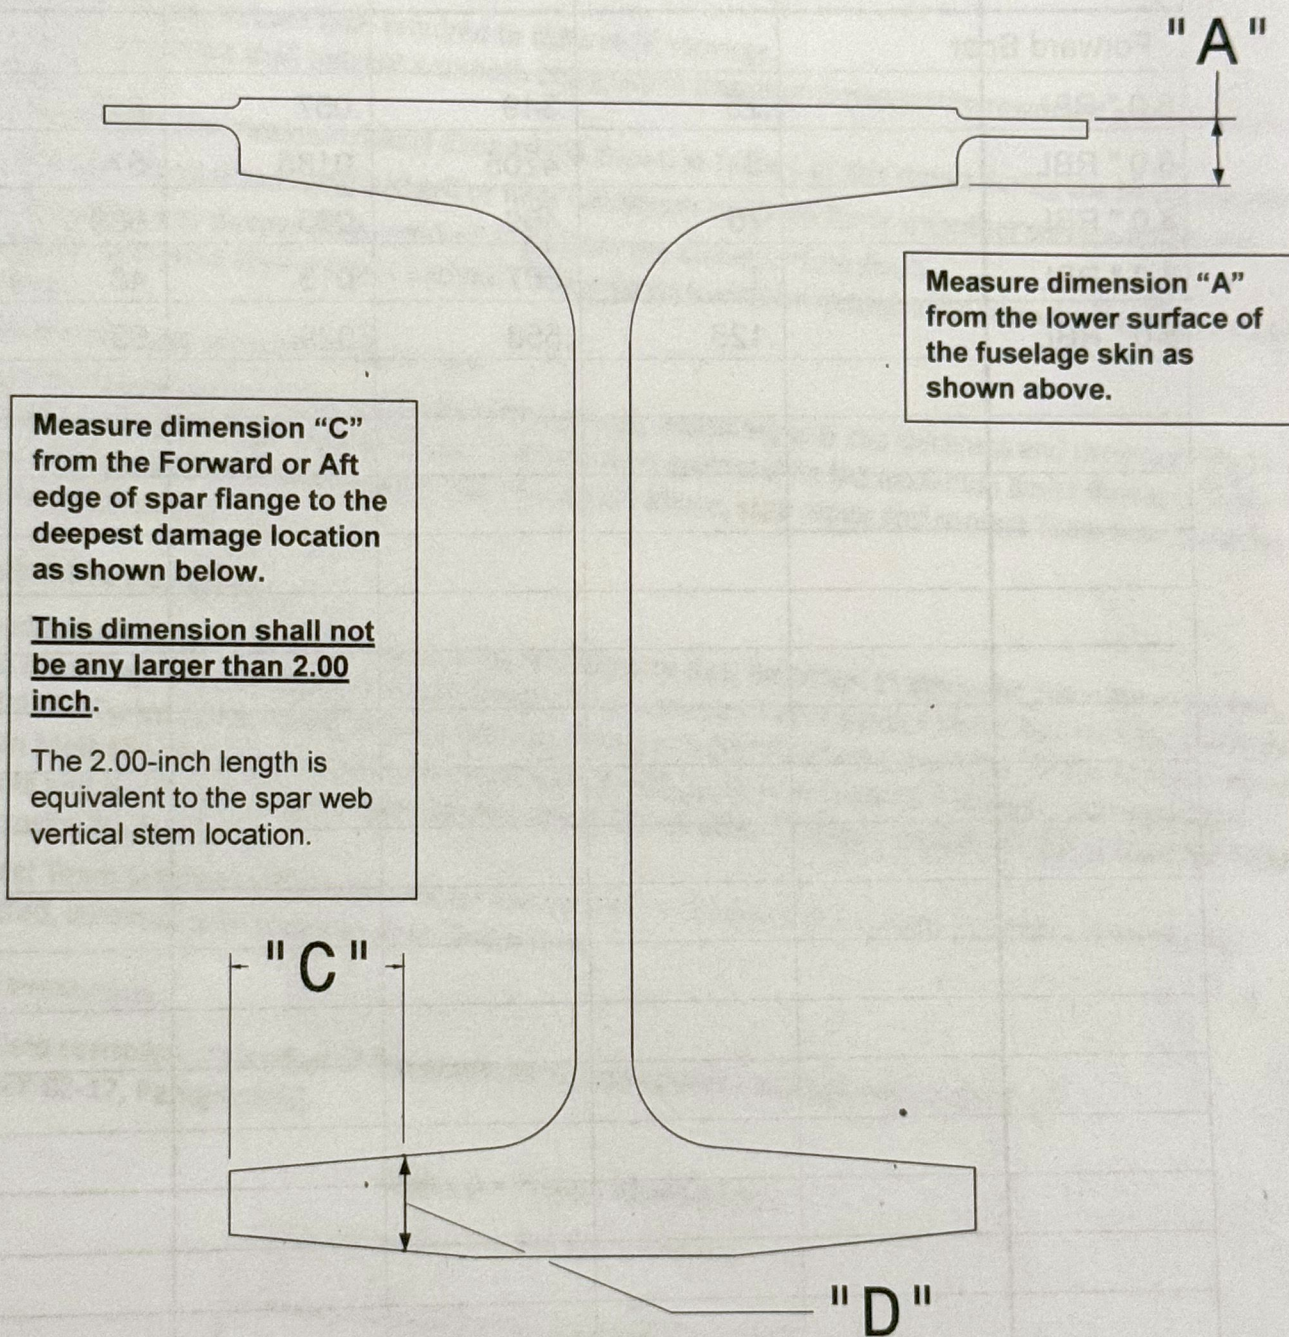
Cross Section of Cabin Carry Thru Spar

"A" – Vertical thickness of end of upper spar flange.

Measure dimension "A" from the lower surface of the skin as shown above.

"C" – Horizontal distance from end of spar flange to deepest spot of corroded area being evaluated.

"D" – Vertical thickness of spar flange at deepest spot of corrosion.

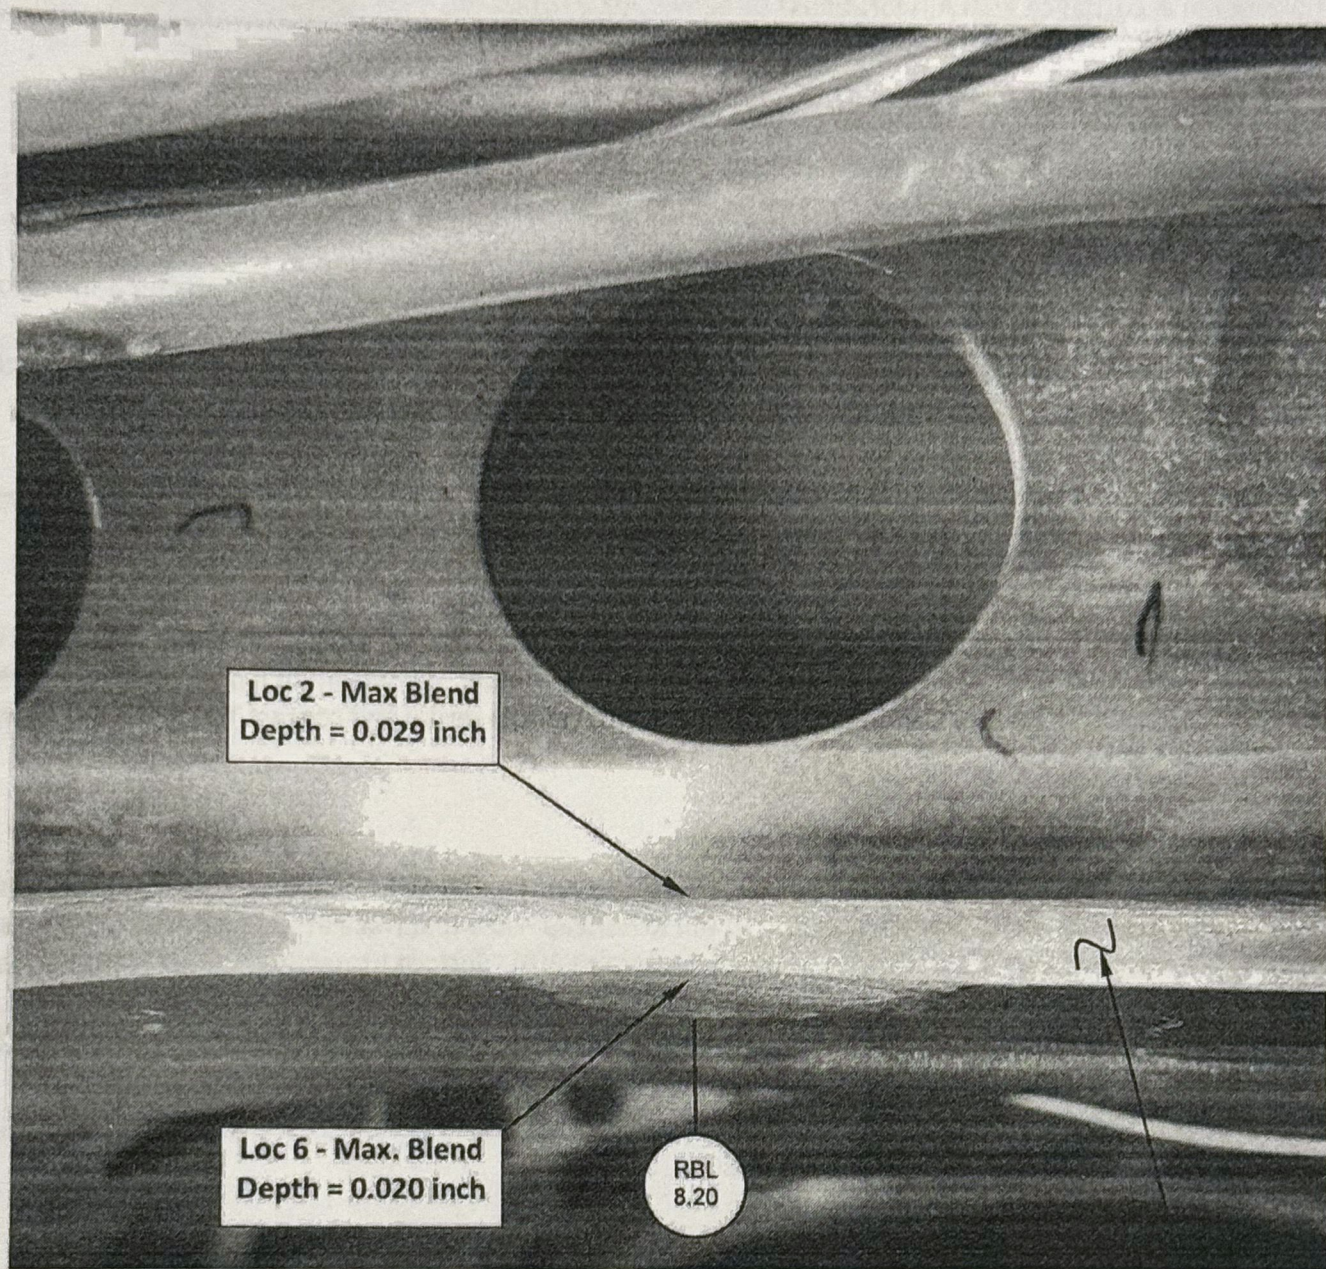
Figure 2 – Close-Up Photograph
 Lower Cap – Upper/Lower Surface – Locations 2 and 6
 (View looking Aft at RHS of Carry-Thru)

Wing Spar - Center
 Section Cantilever
 - Lower Cap
 (P/N 1710703-7)

Site	Location	Spar P/N	Measured Thickness (in)	Nominal Thickness (in)	Max Blend Depth (in)
1 - LCUS	RBL 8.20; FS 123.65	1710703-7	0.507	0.296	0.013
2 - LCUS	RBL 8.20; FS 123.67	1710703-7	0.558	0.300	0.029 *
3 - LCUS	RBL 8.20; FS 123.80	1710703-7	0.365	0.320	0.021
4 - LCUS	RBL 8.20; FS 124.05	1710703-7	0.421	0.360	0.019
5 - LCUS	RBL 8.20; FS 124.30	1710703-7	0.469	0.400	0.005
6 - LCLS	RBL 8.20; FS 123.80	1710703-7	0.365	0.320	0.020 *
7 - LCFE	RBL 8.20; FS 123.55	1710703-7	NA	Edge Blend	0.007

* = At these sites the blend depths from upper/lower surfaces are combined due to damage at the same RBL 8.20. Total blend depth = 0.049 inch deep at the same RBL 8.20.

The corrosion damage found on the lower cap of the Wing Spar - Center Section Cantilever (P/N 1710703-7) shall be blended out and inspected in accordance with the following instructions. Corrosion protection of the lower cap shall be accomplished in accordance with Airworthiness Directive: AD 2023-02-17.

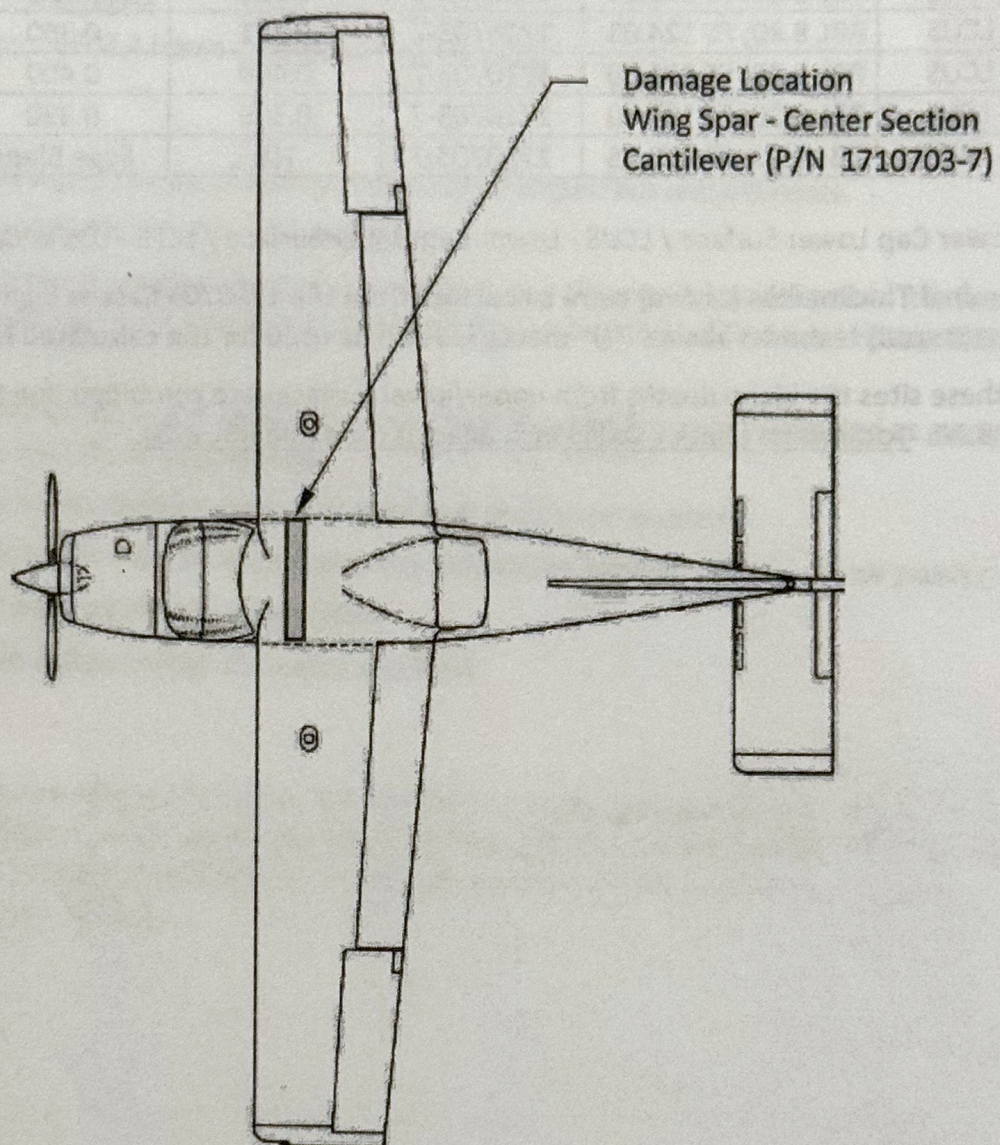
Figure 1 - Damage Location

Figure 1 is a sketch showing the damage locations. Figure 2 is a close-up photograph of the damage sites.

When complying with Airworthiness Directive: AD 2023-02-17, corrosion damage was discovered common to the lower cap of the Wing Spar - Center Section Cantilever (P/N 1710703-7) defined as FS 123.55 to FS 127.55, WL 125.17 to WL 128.16, and between LBL 16 and RBL 16. After corrosion removal, the remaining lower cap thickness, and blended depths are shown in Table 1.
